# Technical Bulletin

Model  
All 911  
C2/C4/T

**Subject:** Ventilation Grill Mounting

**Number**  
9301

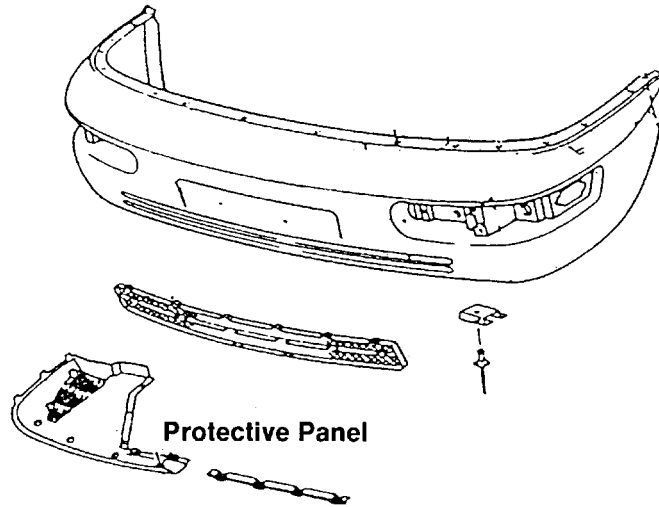
Figure 1

**Concern:** If the mounting points for the ventilation grill in the lower part of the front bumper have been broken, the ventilation grill may be reattached without replacing the front bumper cover.

**Repair Information:** 1. Remove the lower protective panel or panels to gain access to the rear of the ventilation grill (see Figure 1).
