Technical Bulletin

Model
911C2/C4/t

Subject: Central Locking and Alarm
System Malfunctions

Number
9201

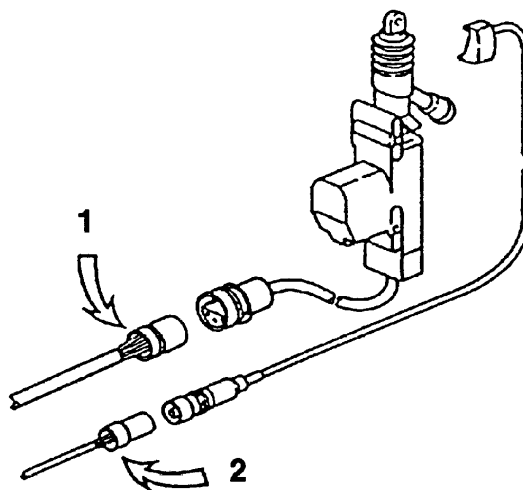
Figure 1

Concern: Water entering door wiring harness. Central locking button /door lock buttons light up, alarm system activates spontaneously. Battery discharges from excessive current draw.

General Information: To prevent water from entering the door wiring harness connectors, the shrink tubing on the locking motor wiring plug (arrow 1, Figure 1) and alarm micro switch wiring plug (arrow 2, Figure 1) was discontinued from production date: April 29, 1991.

Repair Information: When repairing central locking or alarm system malfunctions on vehicles prior to the above VIN numbers, 5 to 10mm of shrink tubing should be removed from wiring harnesses (arrows 1 and 2 in Figure 1).

Cut and remove shrunk tubing carefully. Do not cut into wiring. Clean wiring plug and terminals. Heavily corroded connectors or wiring should be replaced.

Check function of central locking and alarm system after repairs.
