Technical Bulletin

Model
911C2/C4
911 turbo

Subject: Dashboard Cover Deformed

Number
9101

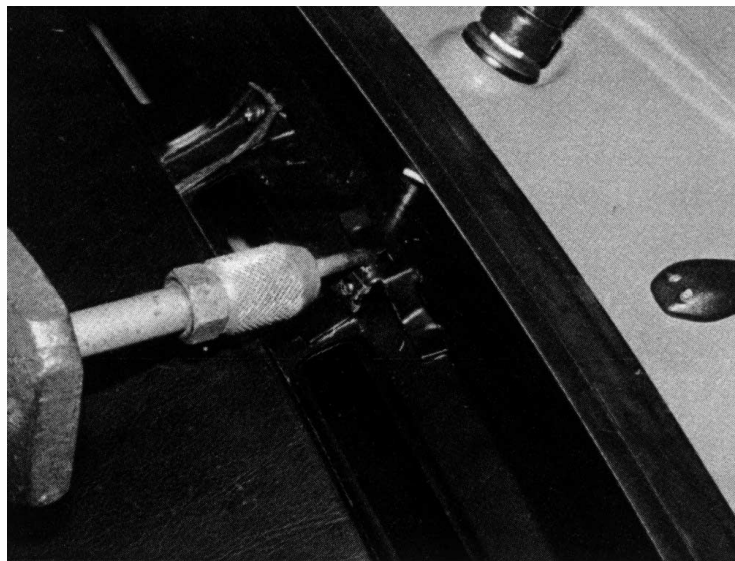
Figure 1

Concern: Wavy appearance of dashboard cover in the area of the defroster vent.

Where repairs are necessary, remove defroster vent. Use slide hammer with a suitable tip (Figure 1) to move defroster vent brackets straight rearward (Figure 2).

Careful: Only light tapping of slide hammer is required to move the brackets.
