Technical Bulletin

Model
911C2/C4

Subject: Seat Belt Bolt Cover, Deformed

Number
9004

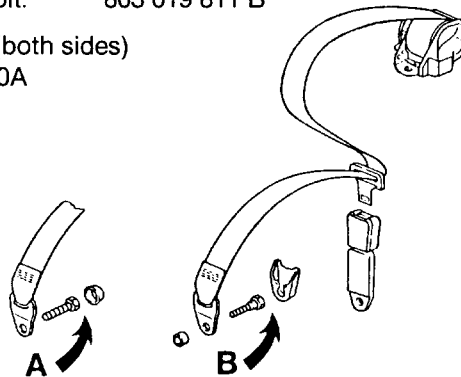
Concern: Hot air from the engine heats up the right rear seat belt anchor bolt and deforms the plastic bolt cover.

Remove bolt cover and bolt (A in Figure). Install new bolt, bushing and cover (B in Figure). Torque bolt to 50 Nm (37 ft. lbs.).

Both sides, left and right should be modified.
