Technical Bulletin

Model
911 C2/C4

Subject: Temperature Sensor for
Engine Compartment Blower

Number
9204

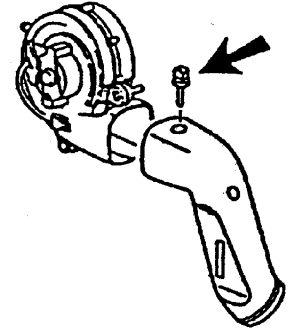
Concern: After the ignition key is removed, the engine compartment blower motor may run on too long or does not switch off which can cause a discharged battery. Corrosion in the temperature sensor for the engine compartment blower may be responsible.

General Information: As of January 1992, the sealing of the sensor contacts and the sensor housing was improved. The sensor with improved sealing is marked as follows:

- Temperature sensor tip has white sealer.
- Electrical connectors are sealed with transparent sealer.
- A green paint dot on sensor housing (temporary).
- Production date stamped in black ink in the area of "Hella" marking.
From production date 421 (42 = week, 1 = 91 year)
indicates new version sensor.

Repair Information: Only the new version temperature sensor is available for repairs. When connecting the cable harness to the sensor, be certain the harness connector sealing gasket is in place.

Parts Information: Temperature sensor Part Number 964 659 120 00
Part number remains unchanged.
