Technical Bulletin

Subject: Noise When Turning Steering Wheel

Number
9205

PORSCHE CARS NORTH AMERICA INC.

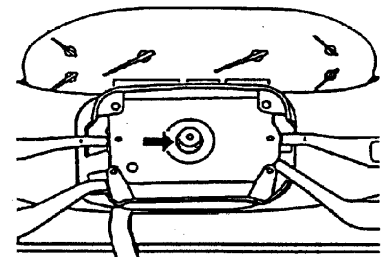
Figure 1B
6 Cylinder

General Information: If noise is heard from the steering column area, it may be caused by a combination switch assembly that is not adjusted properly or by a machining burr on the base of the splined shaft of the steering column.

Step 4: Inspect the base of the spline for any burrs and remove any burrs with a key file or suitable tool. (A burr in this area may cause the turn signal cancelling ring to bind slightly inside the contact reel.) Figures 1A, 1B and 1C show the area where burrs are possible.
